# Manufacturing and characterisation of artificial defects for non-destructive grinding burn detection

Presentation given at the Annual Convention  
of the German Society for Nondestructive Testing DGZfP 2012,  
17.-19.09.2012, Graz, Austria

Martin SEIDEL\*, Antje ZÖSCH\*, Christopher SEIDEL\*,  
Wolfgang KORPUS\*\*, Heinz PÖHLMANN\*\*,  
Bernd EIGENMANN\*\*\*

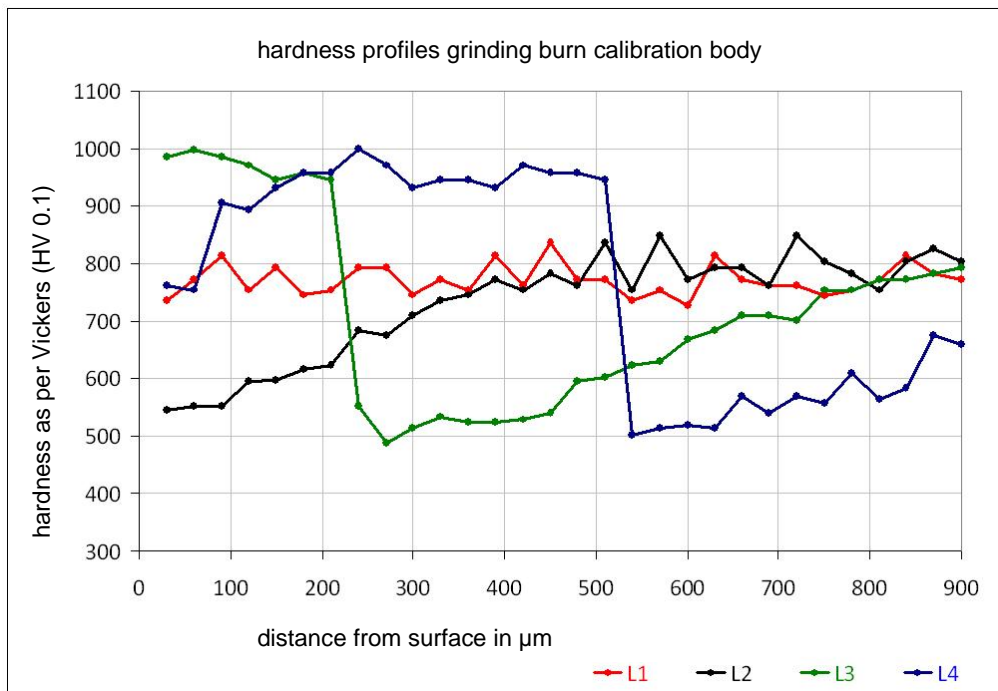
Fig. 3: Micro hardness measurement from edge to core (hardness profile for different laser powers)

The results of the micro hardness measurement at the four laser marks are

displayed under figure 3. The hardness profile is similar to annealing zones and re-hardening zones in real components. In comparison, figure 4 shows as an example the results of the grinding burn mark of a bearing roller: characteristic discolouration of the surface after nital etching; annealing zone in metallographical cut and decrease of hardness values in the area near to the surface which corresponds to the annealing zone.

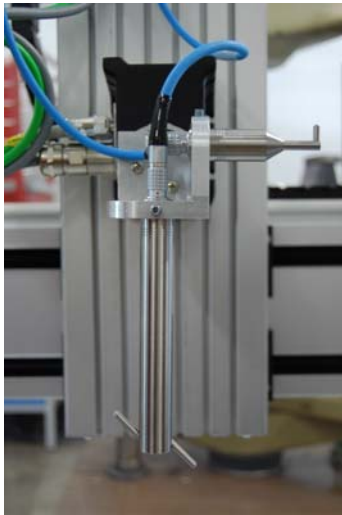
Figure 6.a shows the arrangement of the eddy current crack detection probe when testing a roller bearing inner ring. The angled shape of the probe and the combination of three probes enable access to all relevant surfaces. Fig. 6.b shows a clamped roller. Race and end face are tested at the same time.

a) Probe arrangement

Fig. 6. Grinding burn test by means of QuaSor E

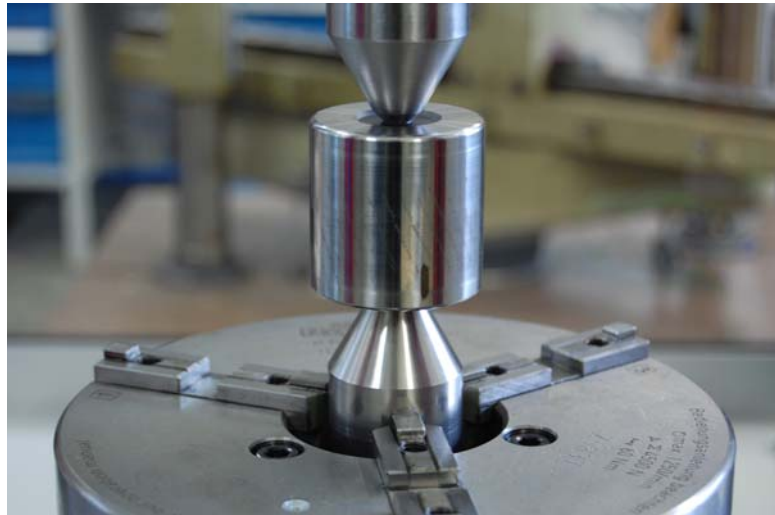
b) Testing a roller

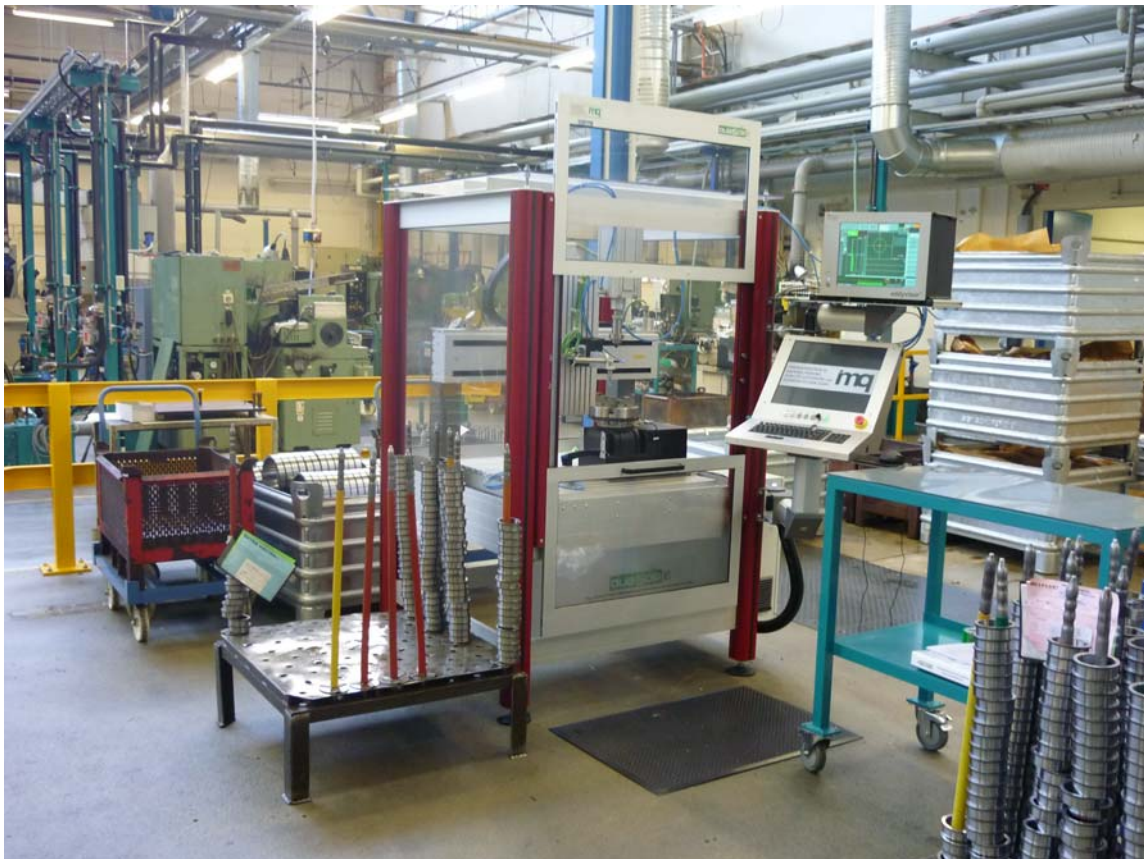
Fig. 7: Test device QuaSor E in production environment at Spindel- und Lagerungstechnik Fraureuth GmbH

The test device QuaSor E is utilised in production for detection of grinding burn and structure defects near the surface (figure 7).

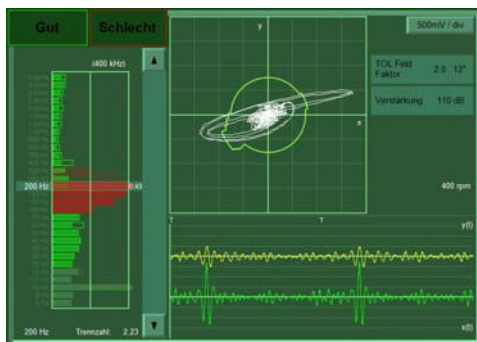
The test signals of laser mark L1 shows no microstructure changes and only a small difference of residual stress resp. half-width of X-ray profile compared with the basic material, result in a separation figure of 2.23 and also stand out clearly from the reference quantity.

a) L1: max. separation figure 2.23  
no visible microstructure change

Fig. 8: Results of eddy current test by means of QuaSor E & eddyvisor on a roller with laser marks L1 to L4 (screenshots IBG's eddyvisor)

Figure 8 shows the results of the eddy current test of the roller with four laser marks. As basis for the evaluation, reference data of the eddy current signals of parts without any defect are gathered. The signals of the tested parts are then assessed relative to the reference data. A separation figure is determined as measure for the deviation of the eddy current signals of the tested part from the signals of the reference parts. The signals of the reference parts are widened by a tolerance zone so that faultless parts have a separation figure of about 0.5. The sensitivity of the test method depends on the defined threshold for the separation figure that triggers NOK sorting of the part.
